From the Board

What They Don't Teach You in Engineering School

Shirish Kardile

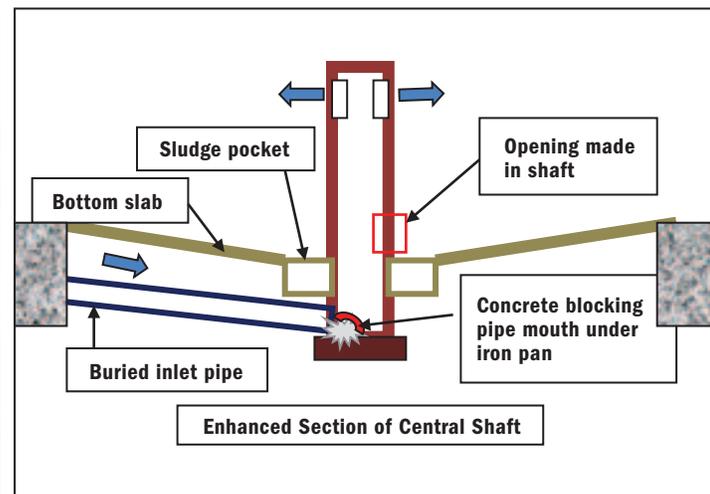
"Eureka!" he cried. At the mouth of the pipe was an iron pan turned upside down and filled with hardened concrete. A thin guy with a crowbar was lowered into the shaft, which was about 1 m (3 ft) deep. The pan and the concrete debris were removed in about a half hour, and the hole in the shaft was plugged in two hours with fast-setting concrete.

Once the problem was solved, the contractor confided to the designer that the central shaft was manually filled with concrete, and leftover concrete was used to fill the shaft. A tired laborer must have accidentally dropped the concrete-filled pan into the shaft at the end of the day.

Above, a clariflocculator is shown under construction. At right, a diagram illustrates the problem faced in Karmala.
