For Want of a Nail, Poor Water Quality Plagued a Small City

Shirish Kardile

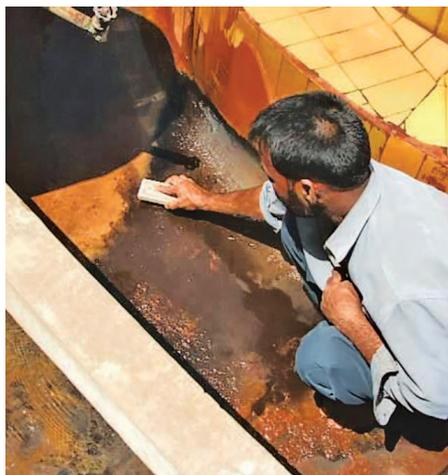
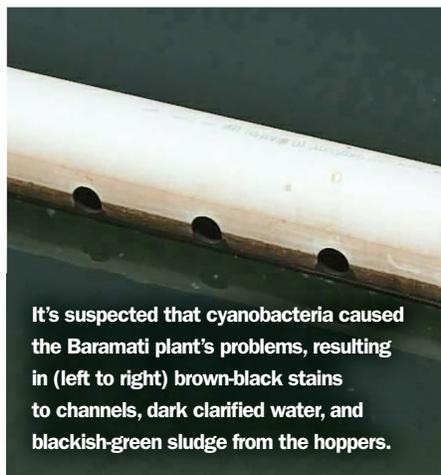
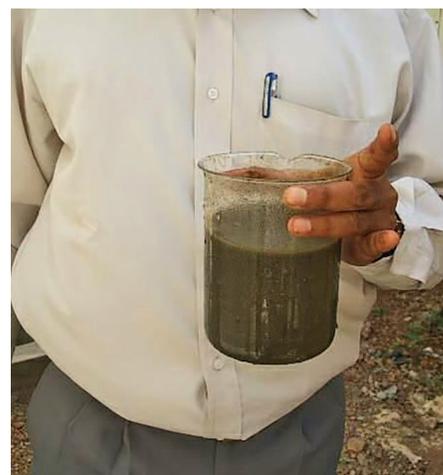
When visiting the plant, I discovered the raw water at the cascade aerator had a putrid odor and a greenish-black color, whereas a visit to the dam intake revealed the surface water was relatively clean. Prechlorination at the plant was causing dark brown and black

stains to appear on the channels' side walls and bottom. Alum was dosed after prechlorination, and the chemical report confirmed the following values: chemical oxygen demand 25–30 ppm, turbidity 10 ntu, pH 8.2–8.5, iron 0.2–0.3 mg/L, and dissolved oxygen above 6 mg/L. An orthotoluidine test confirmed a 2–3 mg/L chlorine level after prechlorination (in the flocculator) and nil at the filter outlet. Filtered water turbidity was 0.7–0.8 ntu, and the water was colorless. Postchlorination was repeated with the same bleaching powder (1.5–2 mg/L), resulting in a color change in the pure water sump. Free residual chlorine (FRC) at the city's distribution reservoir was reported to be 0.2–0.3 mg/L, with the water a pale- to dark-yellow color. The sludge from the tube settler hoppers was greenish black and had good consistency.

It's suspected that cyanobacteria caused the Baramati plant's problems, resulting in (left to right) brown-black stains to channels, dark clarified water, and blackish-green sludge from the hoppers.

Investigations first focused on the MJP intake well, which had three ports at different levels. The lake is fairly shallow at the intake well, about 15–20 ft, and the bottom and mid-level ports were under water. It was obvious that water at the lake bottom had poor quality, containing algae and decayed vegetation. Finally, the likely problem was discovered: the well ports lacked isolation gates. Divers plugged the bottom port with cement bags. Within 3–4 hr, the MJP plant started receiving relatively good-quality raw water.

Fresh bleaching powder with an available chlorine content of about 20 percent was procured at the plant. Because the raw water quality had improved considerably then, only a 0.5 mg/L powder dose was given for prechlorination. The pH of the raw water remained about the same.
