# From the Board

## Town Faces Double Trouble Because of Failed Drainage

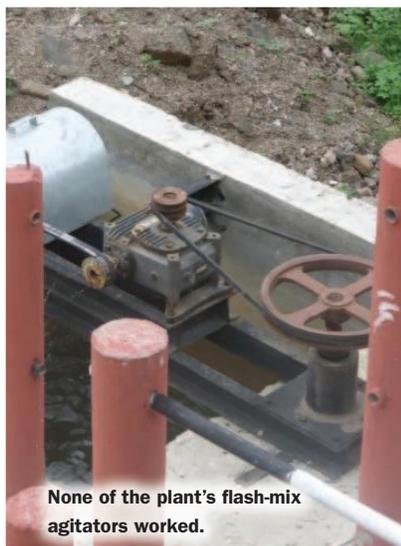
The operators (untrained but for a senior plumber) proudly showed me the newly constructed plant. The raw water turbidity was fairly low, with a green tinge (less than 10 ntu). A casual look at the equipment confirmed that none of the agitators or the clarifier's scraper bridge were operating. Moreover, the filter beds' "pipe gallery" was filled with water.

None of the plant's flash-mix agitators worked.

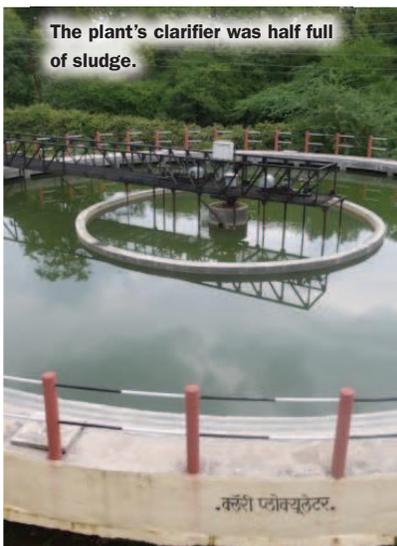
I asked the operator to start the clarifier bridge, and he explained the sludge gets disturbed and "floc" rises up. He further explained the clarifier was half full of sludge. He stopped using alum for the same reason.

When I asked him why the clarifier was filling with sludge, he told me there's "no place for the sludge to go." When draining the clarifier with an underground pipe, the sludge slurry gets accumulated in the *nallab*, a natural drain. Hence sludge from the clarifier accumulates inside. The plant contractor's "scope of work" was only up to the plant boundary. The municipal council was supposed to "deepen" the *nallab* and extend the drainage pipeline to a deeper drain for gravity disposal. However, the municipality had exhausted its funds, and the work was postponed.

The operator explained the risk of the backed-up sludge water entering the pure (filtered) water sump through the overflow pipe, which was at ground level. But he had a solution to the problem. He told me that before monsoon season (a high-turbidity period), he would empty the clarifier and remove the sludge manually.

The plant's clarifier was half full of sludge.

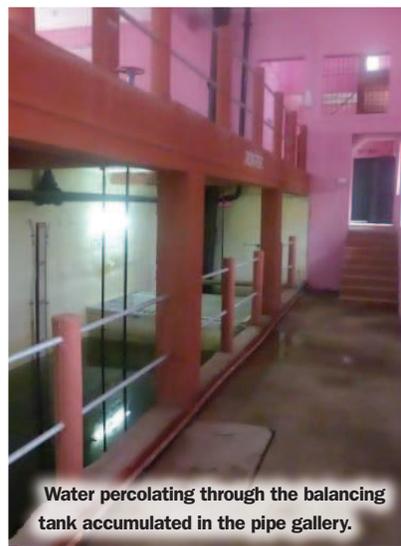
I also asked about the water filling the filter pipe gallery. Apparently the water percolating through the balancing tank accumulated in the pipe gallery. Because the plant was lower, the water didn't drain naturally. As a result, the soil had become supersaturated with the water. The contractor provided pumps to keep the gallery dry, but of course, over time, the pumps had stopped working.

Water percolating through the balancing tank accumulated in the pipe gallery.
